SAFEX INTERNATIONAL

INCIDENT NOTICE

INCIDENT TITLE: Hopper Detonation: Czech Republic

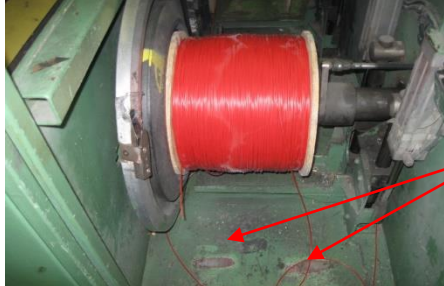
DATE POSTED	REFERENCE	SOURCE
31 May 2018	NI18-05	Austin Star Detonator
INCIDENT OUTLINE		
When did it happen?	Tuesday, August 8, 2017 at 1:30am	
Who experienced it?	Austin Star Detonator Co (ASD)	
What material was involved?	Shock tube in process of manufacture HMX/AL mixture – 200 grams	
What happened?	<p>Immediately following a spool transfer the Shock tube initiated from a slap and shoot inside the take up. The propagation was towards the powder feed unit. The Initiation reached the dosing system and detonated the powder feed unit with approximately 200 grams of HMX/AL mixture.</p> <div style="display: flex; align-items: center;">

<div style="border: 1px solid black; padding: 5px; margin-left: 20px;"> <p>Tube initiated from a “slap and shoot”</p> </div> </div>	
Why did it happen -theory?	<p>The snagger, a component of the take up machine, did not hold the tail end of the spool as it began winding and slapped the machine base at a high speed resulting in the “slap and shoot”.</p> <p>A guillotine safety system designed to cut the shock tube before the propagation could reach the dosing system had failed due to a faulty electrical component.</p> <div style="display: flex; align-items: center;">
